July 11, 2012

Subject: Report for Additional Excavation of DS Tributary and State Road Culvert
Restoration
Detrex Source Control Area – Fields Brook Superfund Site
Detrex Corporation, Ashtabula, Ohio
Docket No. V-W-98-C-450

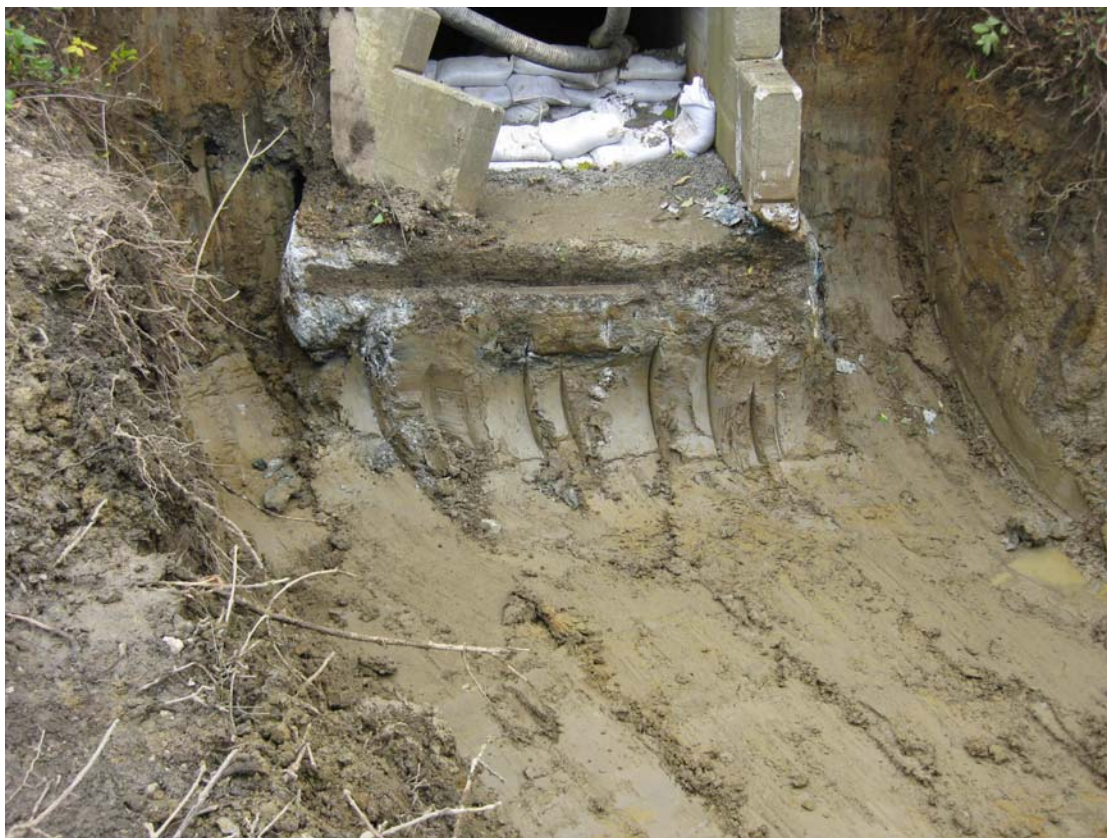
Photo No.
3

The maximum excavation depth was completed surrounding the culvert, approximately 4.1 feet below the original surface elevation. The remaining excavation depth averaged approximately 3-feet below original grade. The excavation areas were left open for at least two hours for visual observation. If no DNAPL was visually observed after at least 2 hours, the excavation was then backfilled. A total of 269.88 tons of sediment/soil were removed and transported to EQ in Michigan for disposal. Copies of the weight tickets and manifests are on file at Detrex.

Excavation completed
surrounding culvert

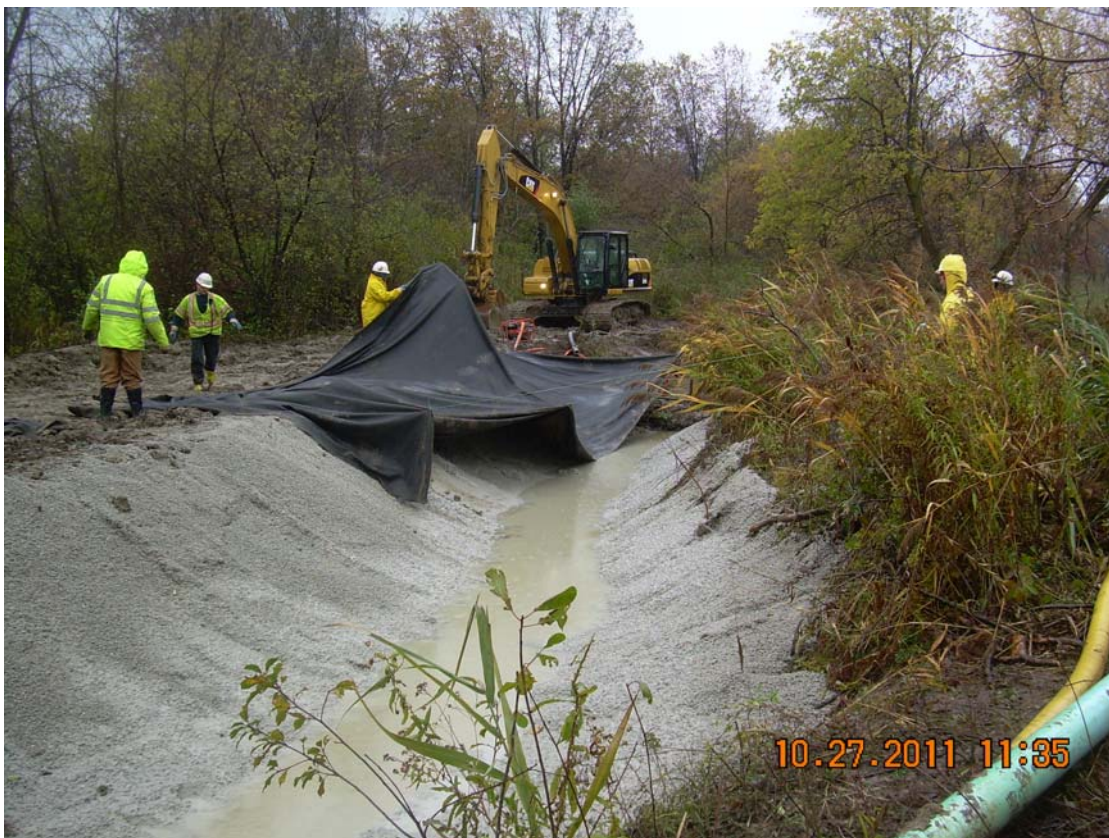
Photo No.
9

Excavation completed,
Aquablok® placed,
covering with non-woven
geosynthetic.

After the excavation areas were inspected (left open a minimum of two hours) and no indications of DNAPL were found, backfilling was initiated and completed October 27 and 28, 2011. Aquablok[®] was placed and spread uniformly in the excavation with a minimum thickness of 24-inches and covered with non-woven geotextile with 12-inches or more of ODOT type D cement filled rip rap (see **Figure 2**). The original plan to use compacted clay over the Aquablok[®] was modified since

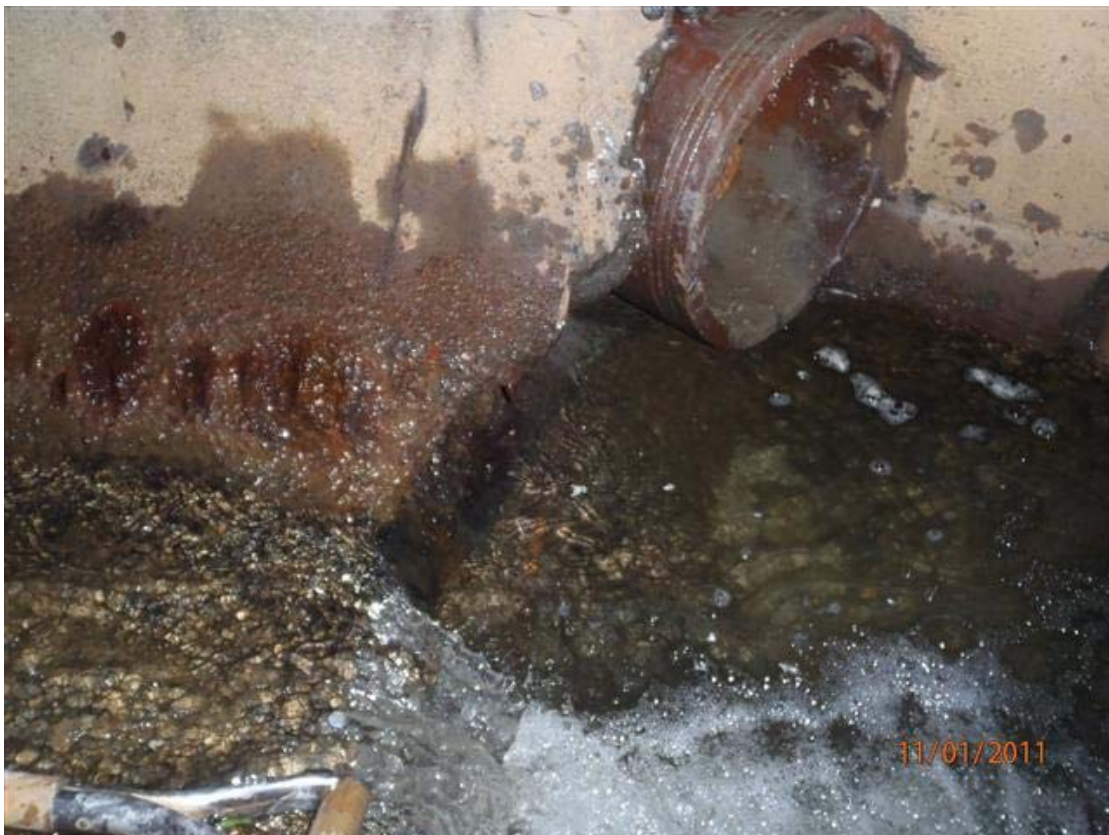
Photo No.
14

Drain tile to be plugged

A 15-inch diameter drain tile was discovered and investigated previously as described the letter report submitted to USEPA on October 13, 2011. The discharge for this drain tile is located inside the box culvert for the DS tributary underneath State Road (see **Figure 1**). SUNPRO personnel plugged the discharge end of the 15-inch drain tile using a wood form with concrete and finished with spray foam and an epoxy coating November 4, 2011. The other end of this drain tile “day lighted” inside a fenced area that formerly was occupied by a gas meter house. A four-inch diameter PVC pipe (tremie pipe) was assembled and inserted into this drain tile. Flowable cement grout (same as used on the rip rap in tributary) was pumped through the PVC to the turning point of the 15-inch drain tile. Two cubic yards were pumped through the PVC tremie pipe. While patching the discharge end of the 15-inch drain tile within the box culvert, a scoured area was observed beneath the drain tile. SUNPRO personnel filled the scoured area with Aquablok® and capped the area with concrete. The concrete cap was sealed to protect the concrete from water.

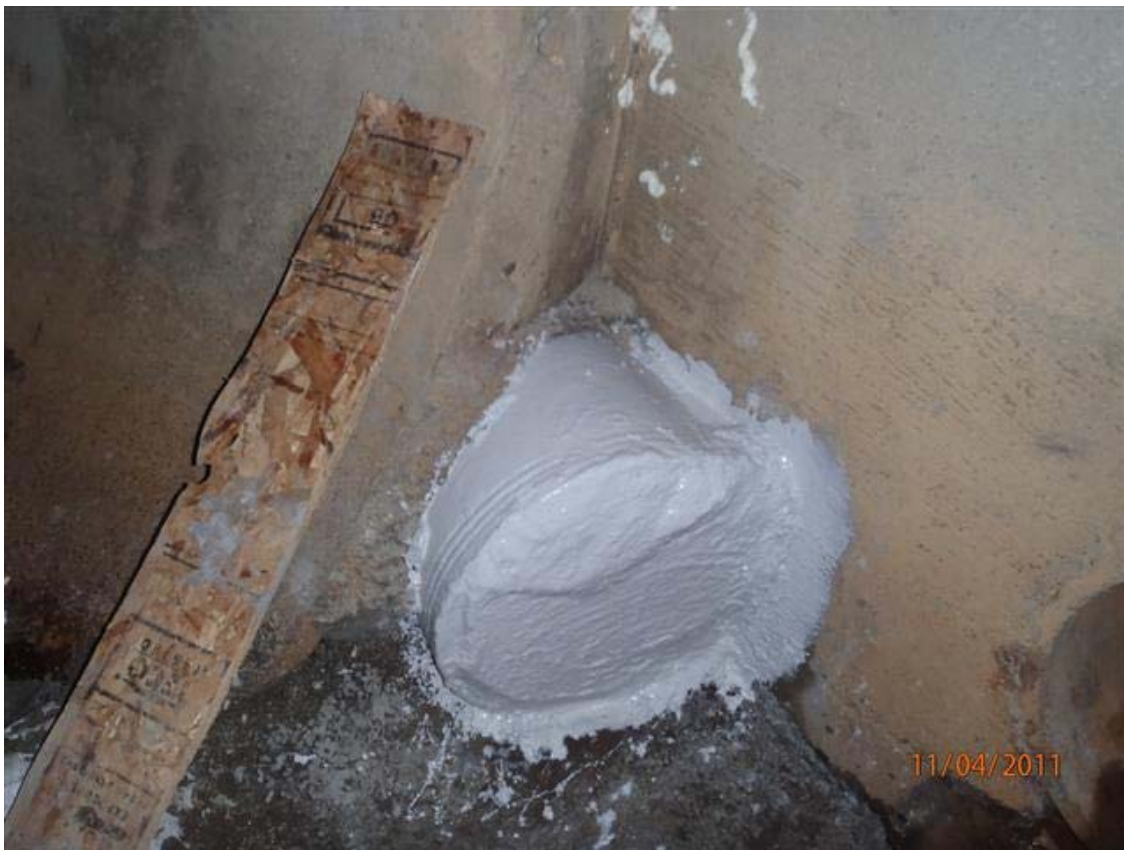
Photo No.
15

Drain tile plugged and coated with epoxy

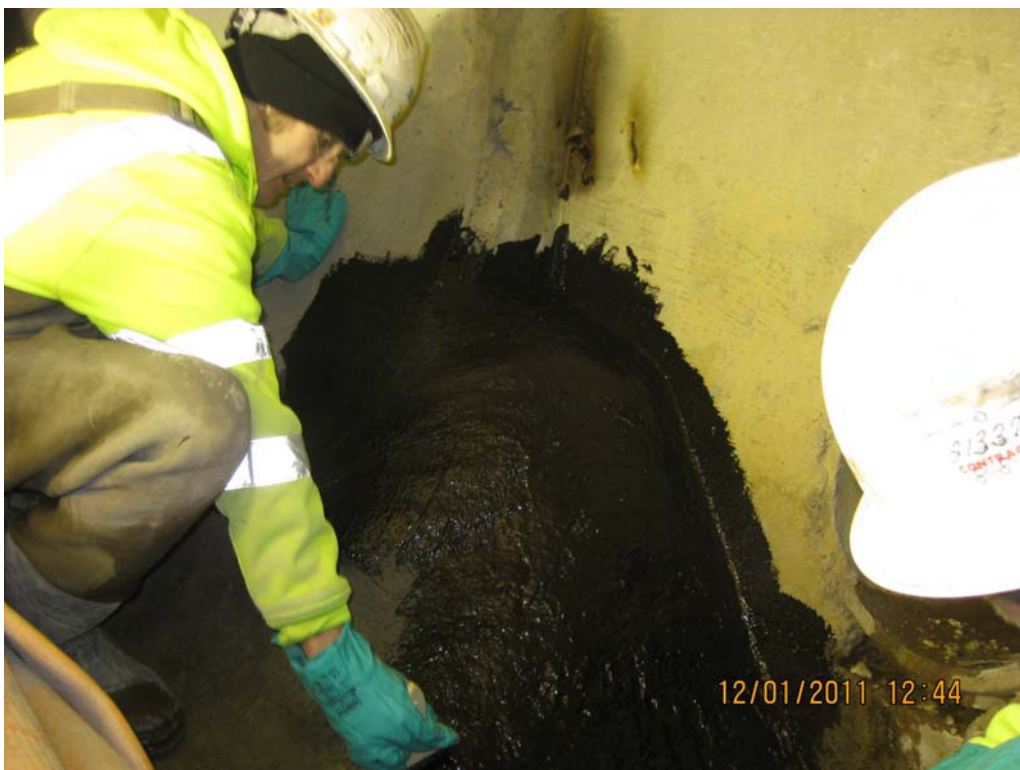
Photo No.
16

Concrete over drain tile and sealed.

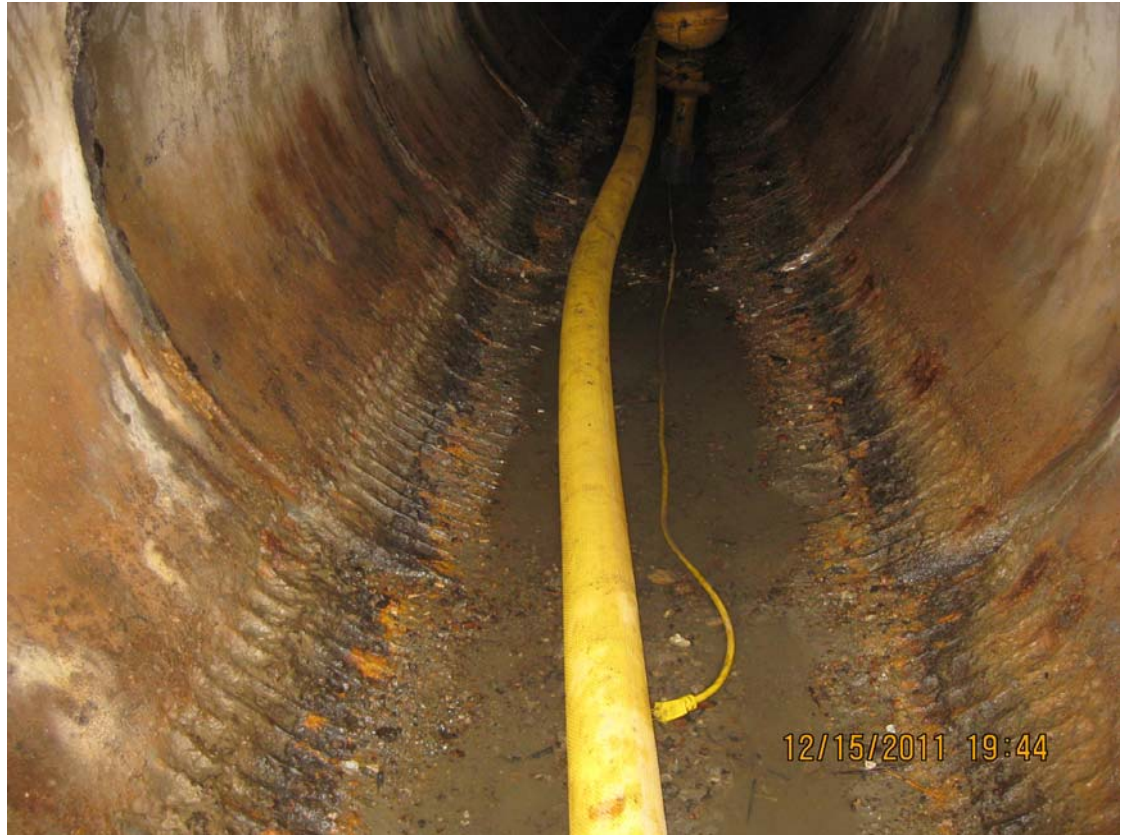
Photo No.
17

Soil/Sediment in the culverts was removed manually with picks and shovels, placed in 5-gallon buckets and transferred into a lined "roll-off" container for off-site disposal. Once the soil/sediment was removed the floor surface was washed and inspected for integrity. The floor surface of the 60-inch pipe was eroded (see attached photo log). The floor of the rectangle culvert was mostly solid except for one area (from 110 feet to 130 feet west of the eastern beginning) where concrete was very thin to absent completely.

60-inch culvert after cleaning. Note how bottom is eroded to metal "rebar"

No fill was used beneath the concrete for restoration of the 60-inch pipe. The area described above in the rectangle culvert where the floor was eroded, Aquablok[®] was used as fill material beneath the concrete. ODOT specifications for concrete repair of culverts were followed. Four to six inches of concrete was poured and finished in the entire length of the culvert (both round and rectangle).

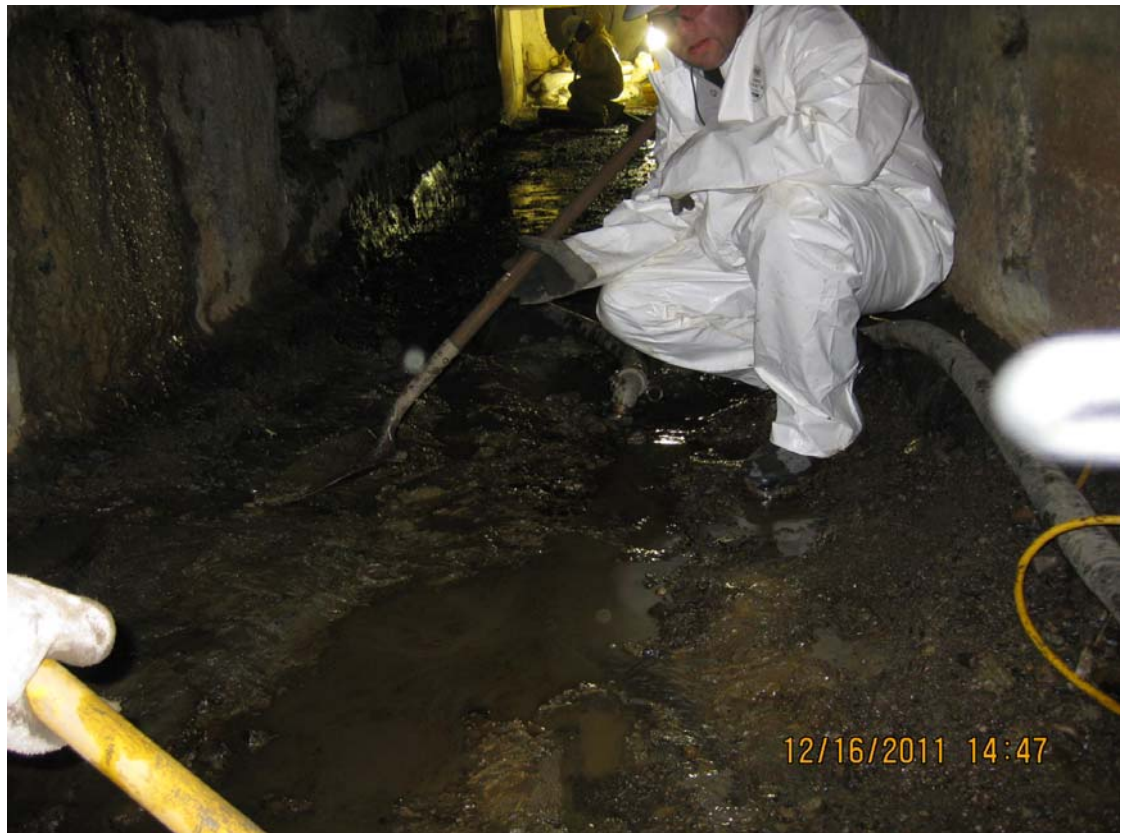
Photo No.
18

Box culvert during cleaning. Area shown as discussed in text where floor was in poor condition.

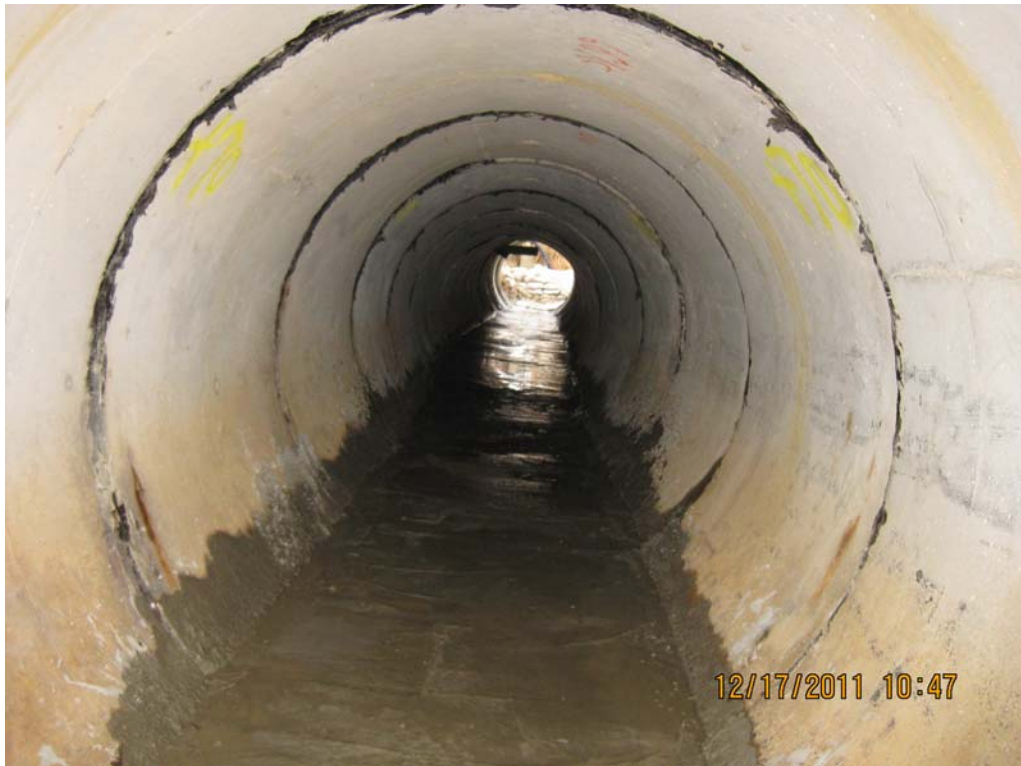
Photo No.
19

60-inch culvert after
concrete poured.

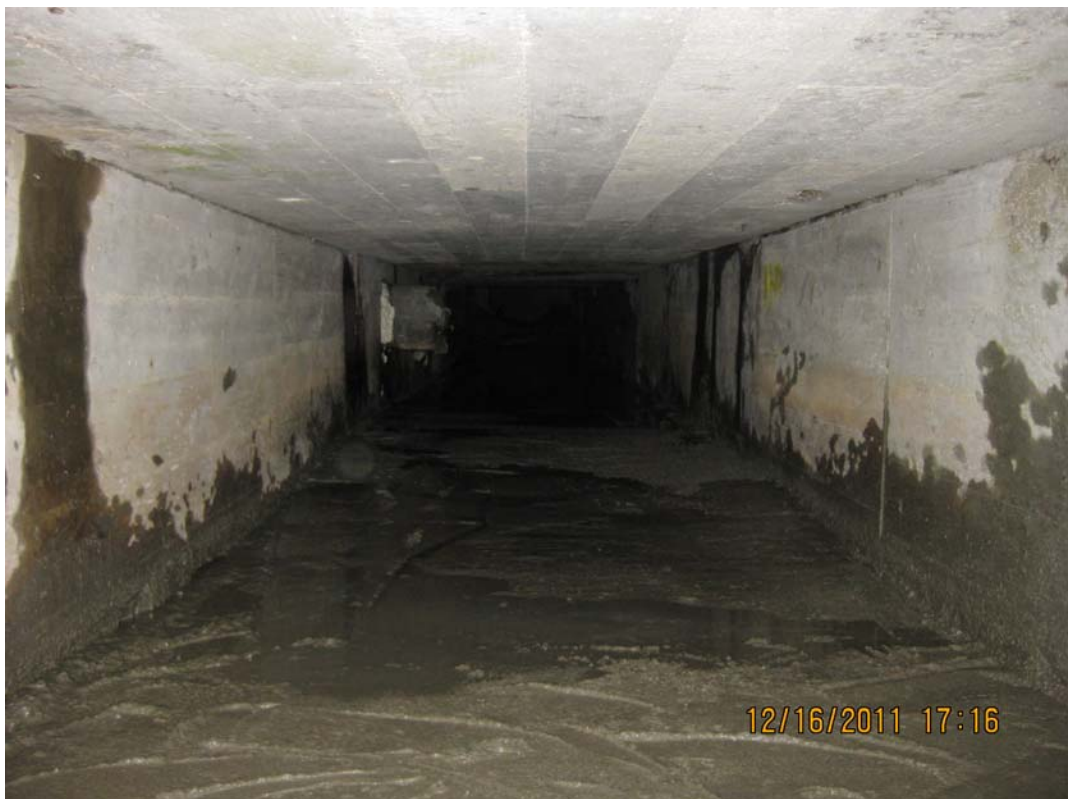
Photo No.
20

Box culvert after
concrete poured.

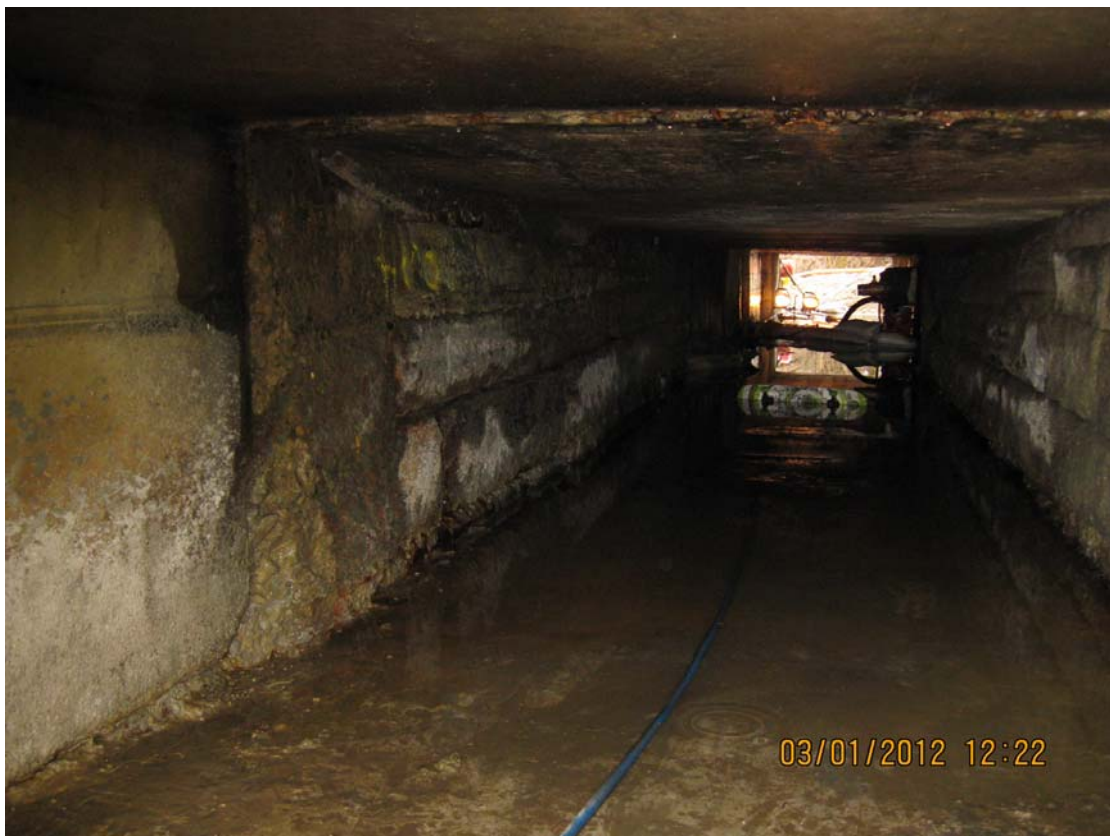
Photo No.
22

During routine follow-up inspection of the DS Tributary and the culvert it was discovered that DNAPL was still being released. A water by-pass around the culvert was constructed and inspection of the culvert was completed by URS, Detrex and SunPro. It was determined that DNAPL was seeping within the culvert. The seep was at an area where the floor intersected the south wall of the culvert. This area of the culvert was constructed of sandstone blocks (probably original State Road crossing) and extended with concrete (See Photo 22).

Inside box culvert
looking west showing
Sandstone block walls

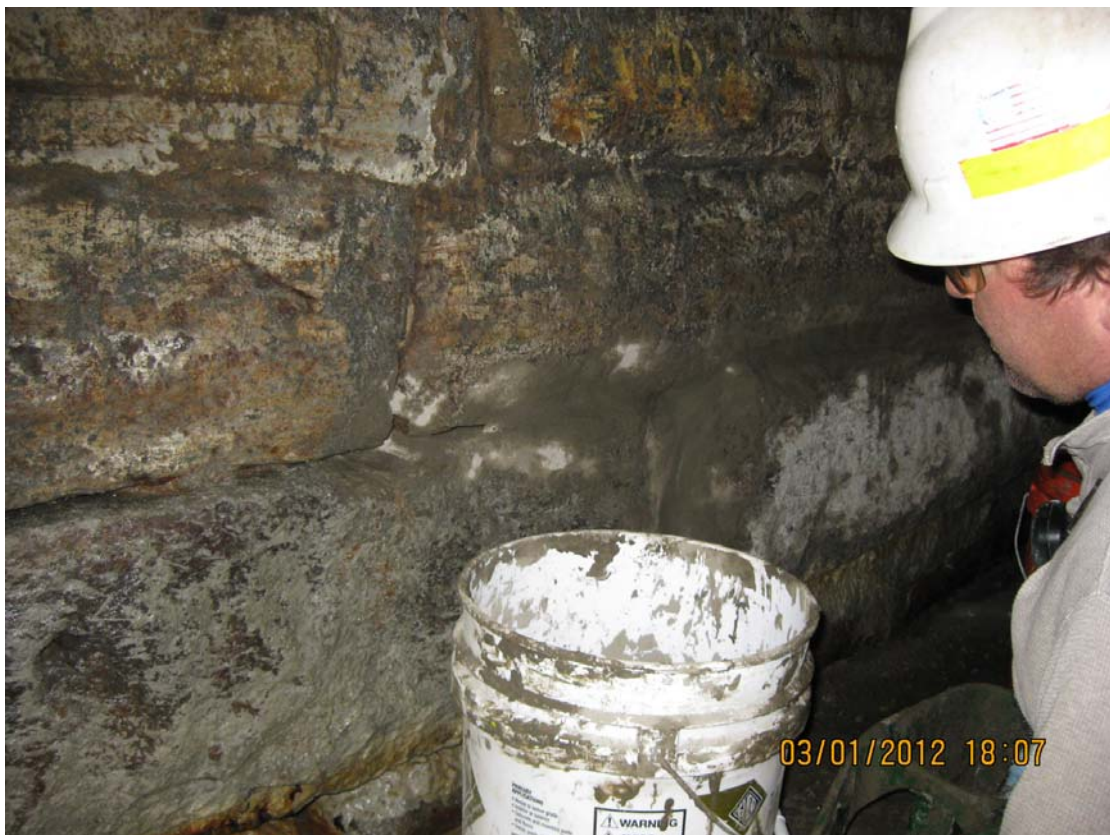
Photo No.
23

Sandstone block repair
of mortar joints

The mortar joints of the sandstone were repaired and additional concrete was poured within the rectangle portion of the culvert. An additional 10-inches of concrete was poured on March 2, 2012. The new concrete was formed to cover the original contact of the floor and the wall.

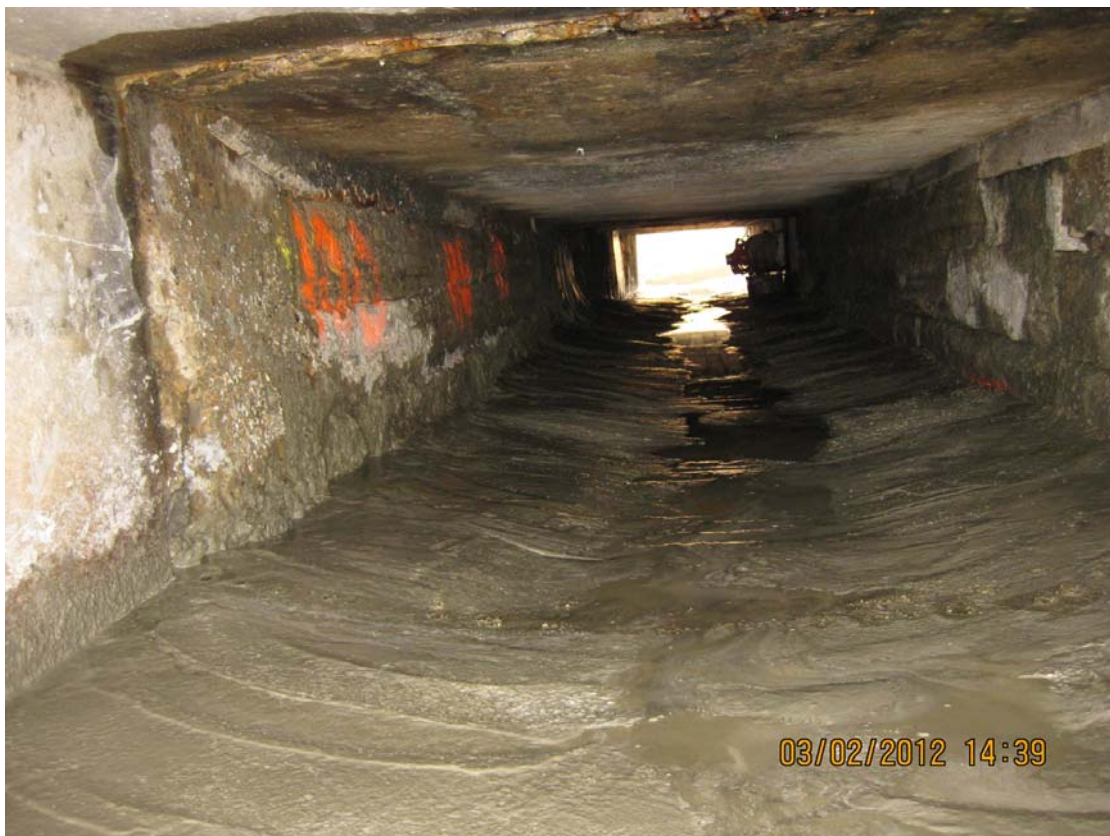
Photo No.
24

Second pour on concrete floor (~10-inch). Note concrete up sidewalls to cover original contact.
